March 1999

**Technical Assessment of the Irrigation Systems of Marigot
and Jacmel and Preliminary Observations
on the Marigot Watershed**

Kyung H. Yoo and Dennis A. Shannon

**SECID/Auburn PLUS Report No. 47
USAID/Haiti Agriculture and Economic Growth Office**

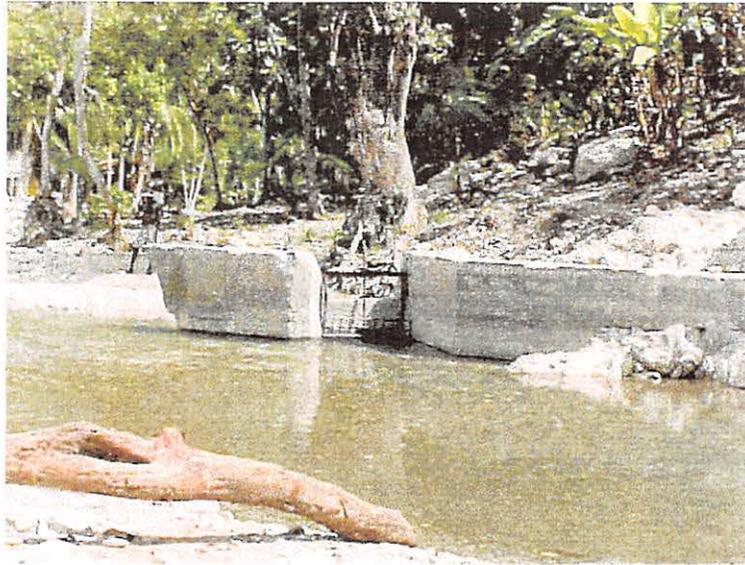
Both irrigation systems have severely damaged intake structures (photos 1 and 2) and conveyance structures on the intake side (photos 3 and 4). Based on observation of the Rodaille irrigation area, the irrigation field and most portion of the main canal and two secondary canals (photos 5 and 6) were not damaged as severely as the upper section of the main canal and the intake structure. However, most of the main canal section was badly sedimented at the time of visitation (photos 7 and 8). The sediment should have been carried and deposited by the flood from Hurricane George and/or sediment-carrying irrigation water during the normal operation. If the latter is the case, the irrigation system lacks scheduled maintenance of canal cleaning. Due to time constraints and logistics we did not visit the command area of the Belle Roche site. But we found that the intake structure and upper section of this irrigation system were severely damaged (photos 9 and 10). Each site will be described in terms of the damage and recommendations for renovation. The consultants were told that a local contractor has been selected for planning and designing of the water intake structure and the irrigation conveyance system renovation for both sites. Since the contractor is in the design stage of the system, our recommendations may be used to verify or confirm their plans.

Photo 1. Inlet structure at Rodaille site. Note the broken and washed out left wing and rock-anchored right wing. Main canal is located behind the sluice gate.

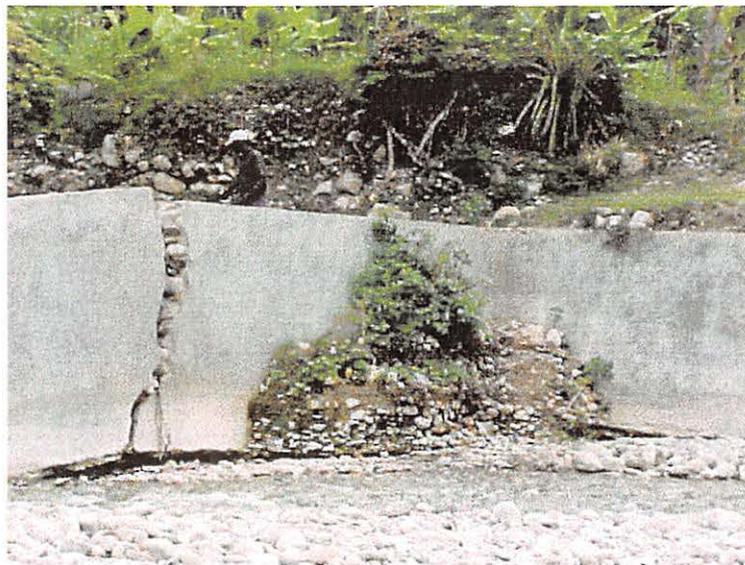
Photo 2. Intake structure at Belle Roche site. Note the broken left wing. The intake sluice gate locates behind the wall covered with grass.

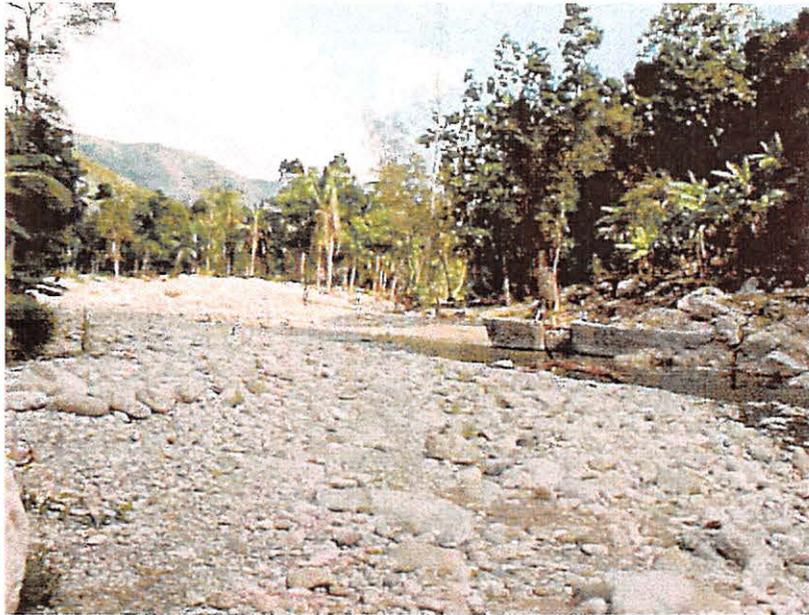
Photo 3. Damaged upper section of main canal at Rodaille site. The embankment on the left of the intake structure was broken and washed out and the river bottom was exposed to the main canal.

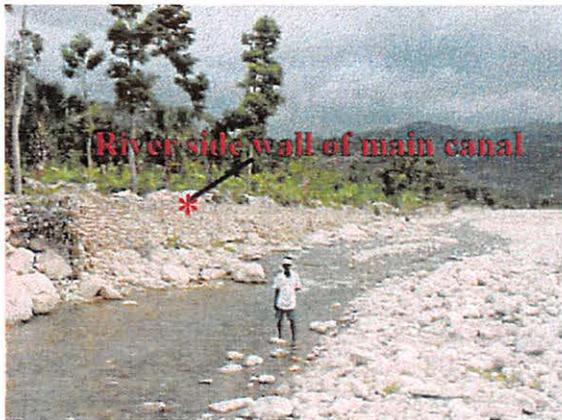
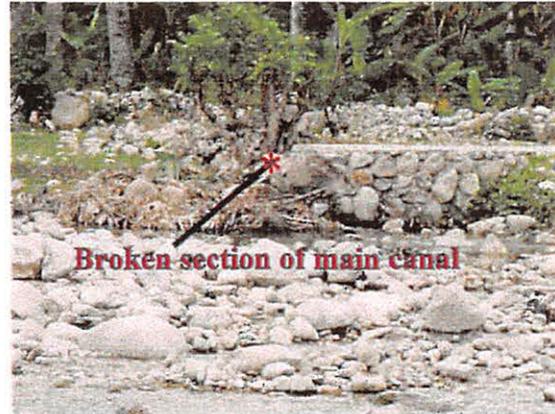
Photo 4. Upper section of main canal at Belle Roche below the intake structure has survived due to the rock wall structure, but the lower part of this section has been broken as shown in the right photo.

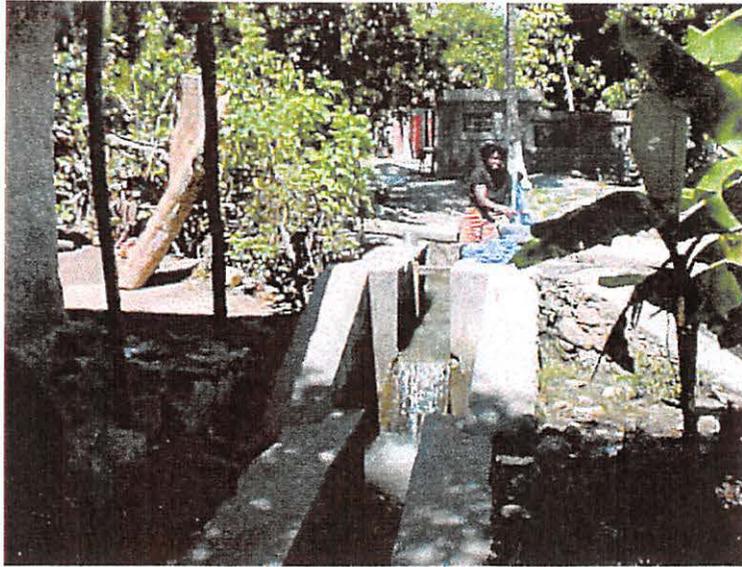
Photo 5. Fully functioning west-side secondary canal even when main canal is dry.

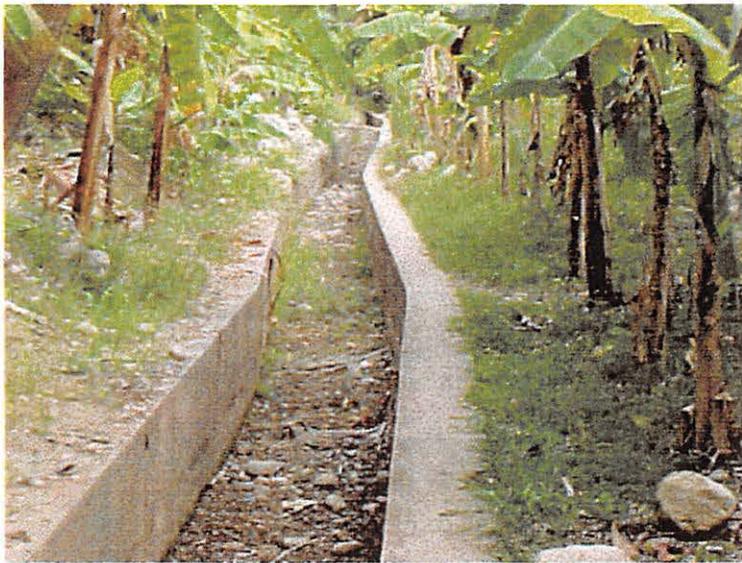
Photo 6. Undamaged section of main canal. Except for the upstream section the main canal below the siphon structure survived the hurricane George. Sedimentation and trash accumulation were excessive which would cause serious problems if not adequately cleaned up.

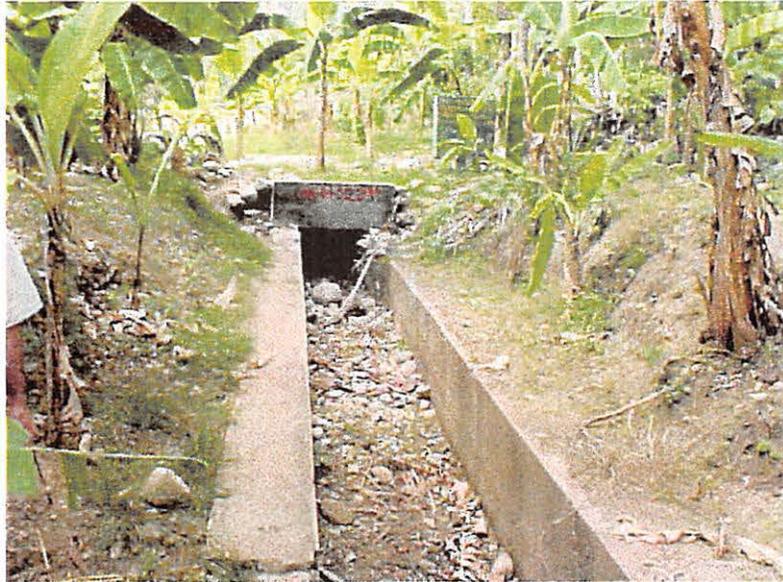
Photo 7. Sediments and trash accumulated in a section of main canal. This is outlet side of the siphon. The canal structure is near perfect at this and most sections of the main canal. Most damage was done to the intake and siphon sections.

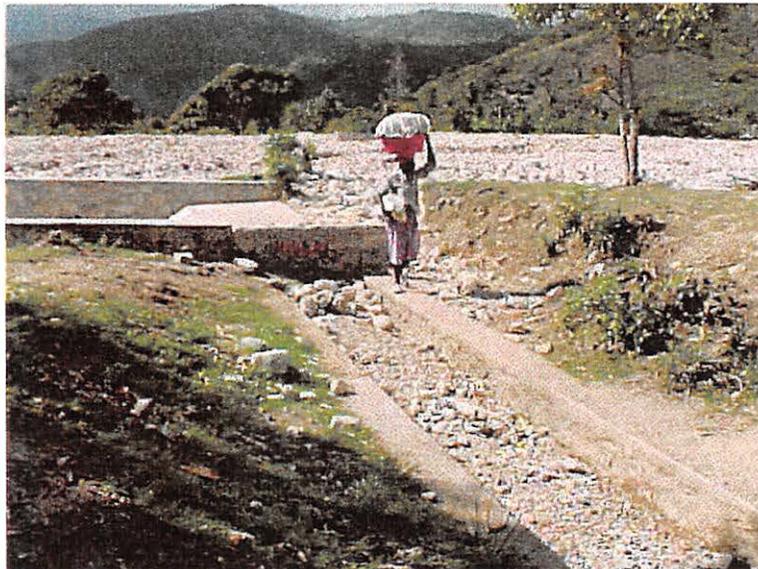
Photo 8. Sediments completely filled up the main canal at the outlet site of the closed conduit. This was caused mainly by the flooding.

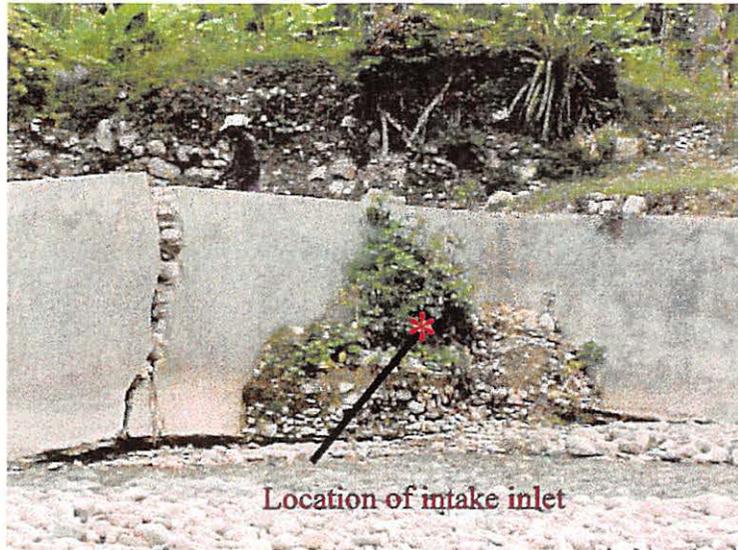
Photo 9. Damaged intake structure at the Belle Roche site. Damaged left wing and washed foundation of the structure.

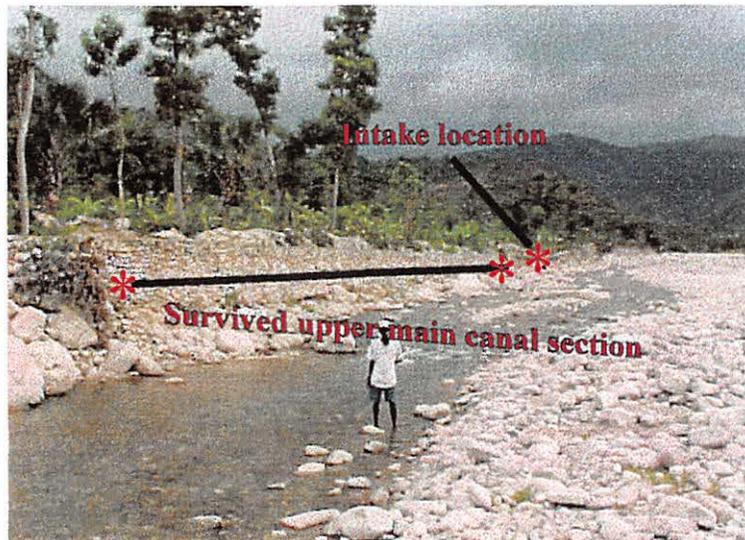
Photo 10. Damaged upper section of main canal at the Belle Roche site. The rock walled section of the main canal survived the flooding but the left end of the section was completely cut off.

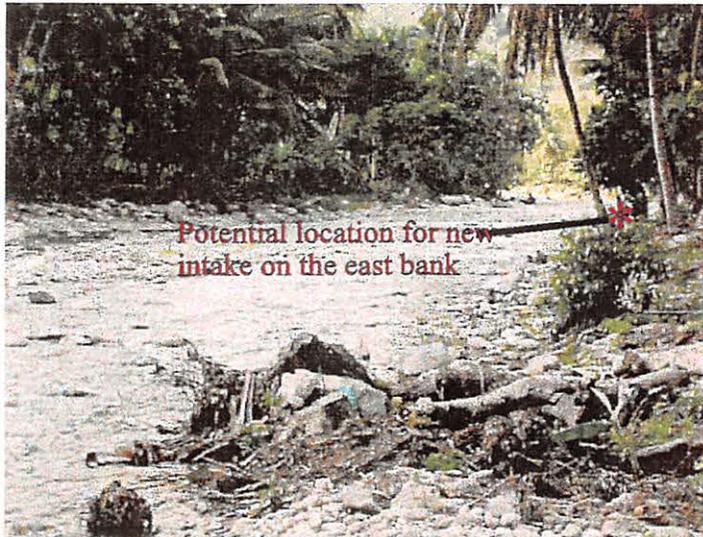
Photo 11. Potential location of a new intake site on the east bank of the river to avoid a river crossing structure. Location is determined by the elevation change in the river which should be high enough for gravity supply to the undamaged section of the main canal. The new connecting section may be routed near the foothill to avoid future damage by flooding or bank erosion.

- 1. Severely damaged intake structure** - A new intake structure should be located on the east bank (photo 11) to avoid a stream crossing structure such as a siphon or flume. An upstream site from the current intake should be chosen to achieve this relocation. This observation agrees with the current plan by a local contractor which was mentioned to the consultants. However this will require a new upper section of main canal to connect to the existing main canal section that survived the hurricane.

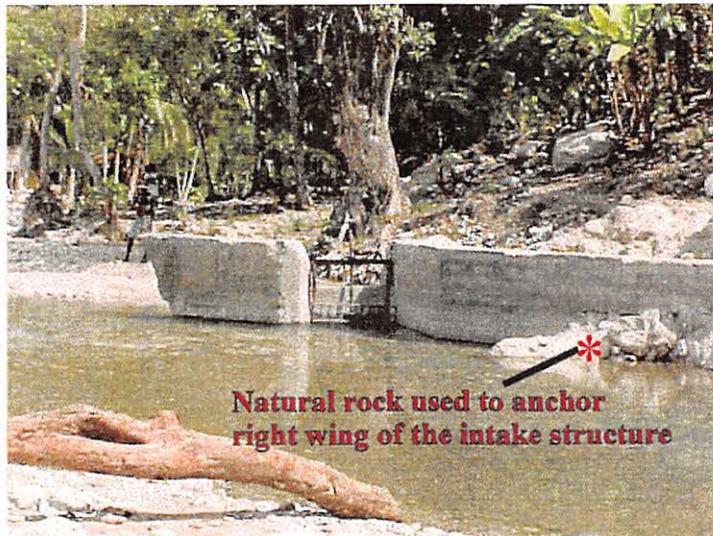
Photo 12. Intake structure at the Rodaille site. Note that the natural rock on the right wing which was used to anchor the structure. The right wing survived the flooding due to the anchor. It is a good idea to anchor an intake structure to a strong object such as natural rock. In case no such object is found, an artificial structure similar to natural rock may be located at more convenient and proper location for intake structure. Existence of such anchoring object should not govern the location of intake.

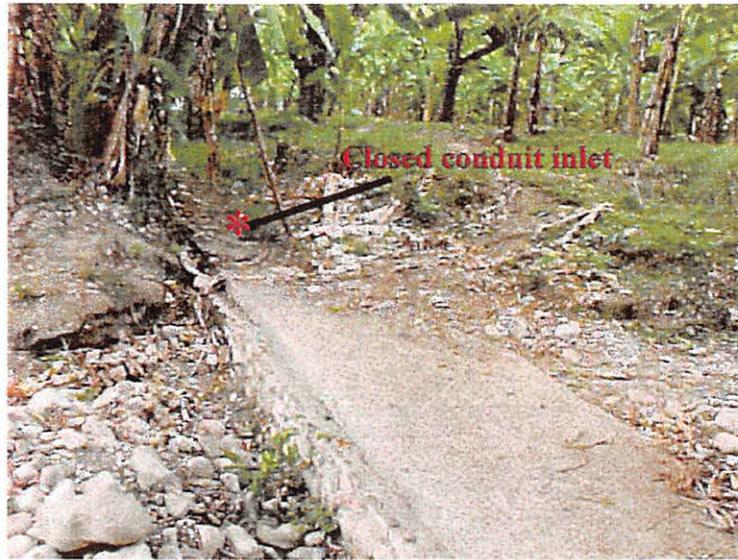
- 3. A sediment-filled box-type closed conduit crossing the dry bed river** - It appeared that the long closed conduit has no other damage than sedimentation in it (photos 13 and 14). This was observed from its inlet and outlet and manholes along the conduit. Some manholes have a raised access but at least one of them has an access lower than the ground level where foreign materials could easily enter. The main canal section between the outlet of siphon and the closed conduit was completely sedimented from the flood water (photo 15). Except for the sediments deposited in the upper section of the main canal, the rest of the conveyance system does not show any serious damages. **It is suggested to save the upper section of the main canal below the siphon outlet and whole length of the closed conduit. This would be done by re-routing the main canal from the new intake structure at or below the outlet of the existing siphon if feasible (photo 16). However, it will require certain conservation practices along the eroded east bank (photo 17) in order to stabilize the main canal below the siphon outlet and**

Photo 13. Practically undamaged closed conduit structure crossing dry-bed river. The conduit may have been filled with sediment from the flooding.

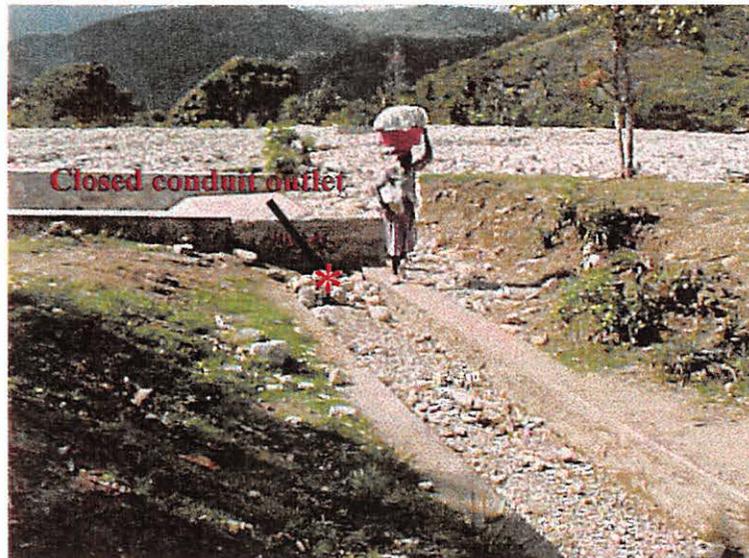
Photo 14. Sediments and gravel filled main canal at the closed conduit outlet.

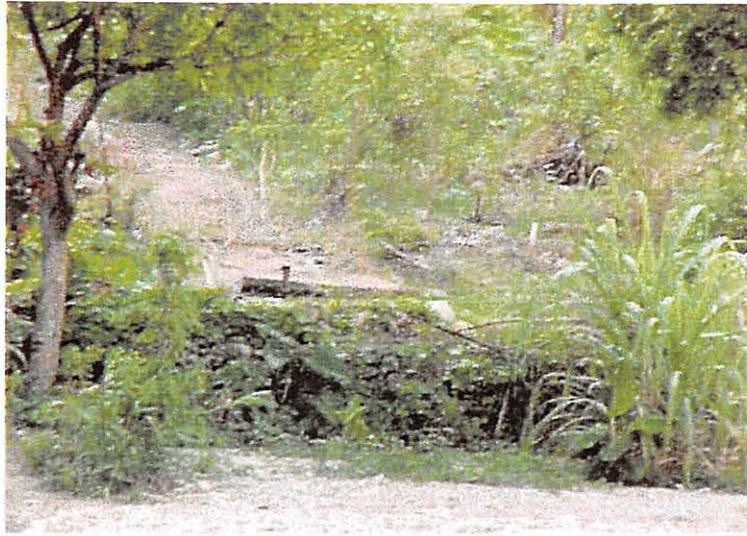
Photo 15. Main canal section between siphon outlet and closed conduit inlet.

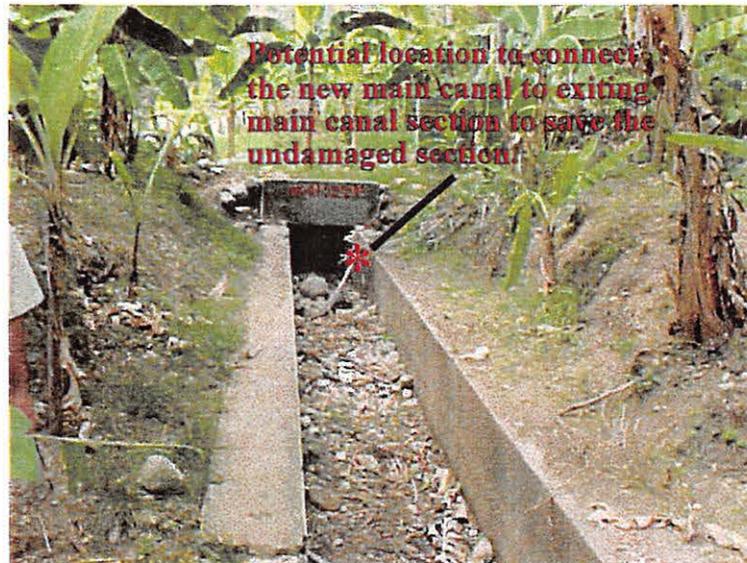
Photo 16. Potential site to connect the new main canal to exiting main canal to save the existing main canal and the closed conduit.

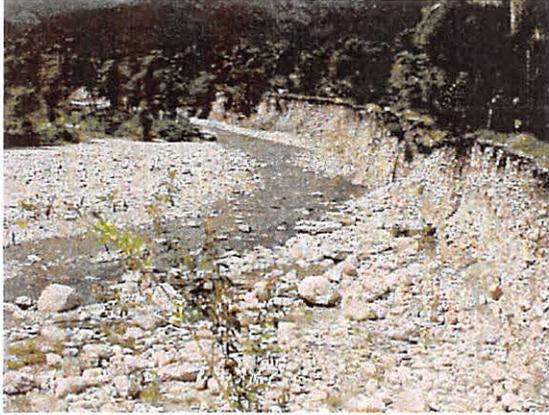
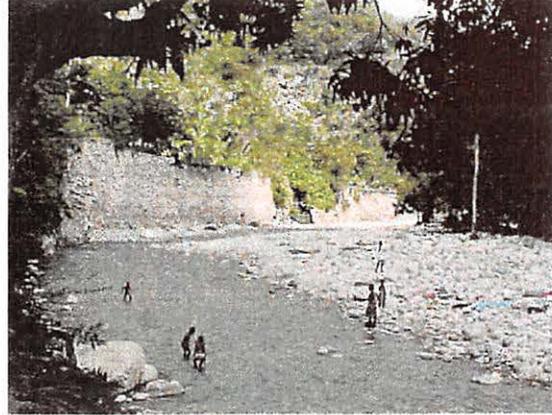
Photo 17. Severe bank erosion which destroyed the road and canal. Left: from downstream side. Right: from upstream side. A drastic river course change is required to prevent further bank erosion.

other infrastructure from flooding. Otherwise it is recommended to re-route this section of the main canal further inland near the foothill and connect to a more stable section of the main canal and to the closed conduit. Such structures as siphon, closed conduit and flume are the most expensive structures per length to build for an irrigation conveyance system.

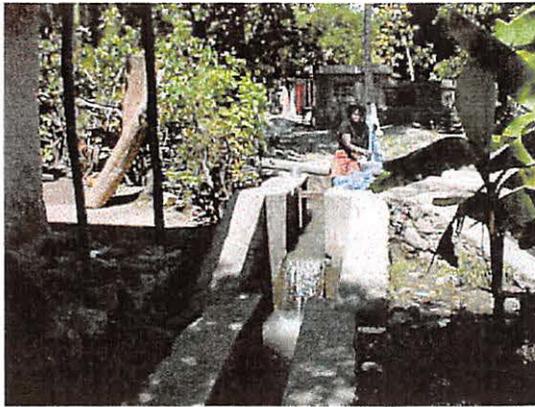
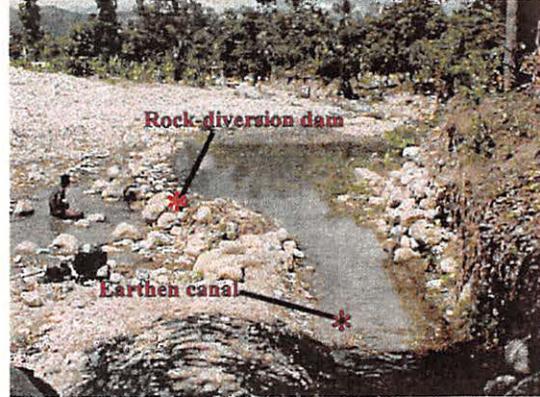
4. The irrigators in the westside secondary canal have started to damage/abuse the conveyance systems to get water into the canal - This damage to the irrigation system is an indirect effect of the hurricane. The west-side secondary canal (photo 18a) had water flow at the time of observation. The water was carried from the river using a rock diversion dam (photo 18b) and an earthen canal which the irrigators installed. The water was conveyed to the secondary canal by the earthen canal (photo 19). Also a portion of the water was conveyed to a nearby field by passing the water through a dug-out hole under the secondary canal. We did not observe any other cases, but if the situation (no water supply in the main canal) continues, there will be more of this and similar types of damage/abuse and eventually irreversible damage will be done to the irrigation system. One observation showed that canal maintenance was not adequately done, due to lack of flow or lack of a maintenance program. This was shown by the accumulated trash and sediments in most of the canal sections.

Photo 18. West side secondary irrigation canal which carries water where the main canal is dry. The water was diverted by a rock-diversion dam and an earthen canal built by the irrigators of the west side secondary canal.

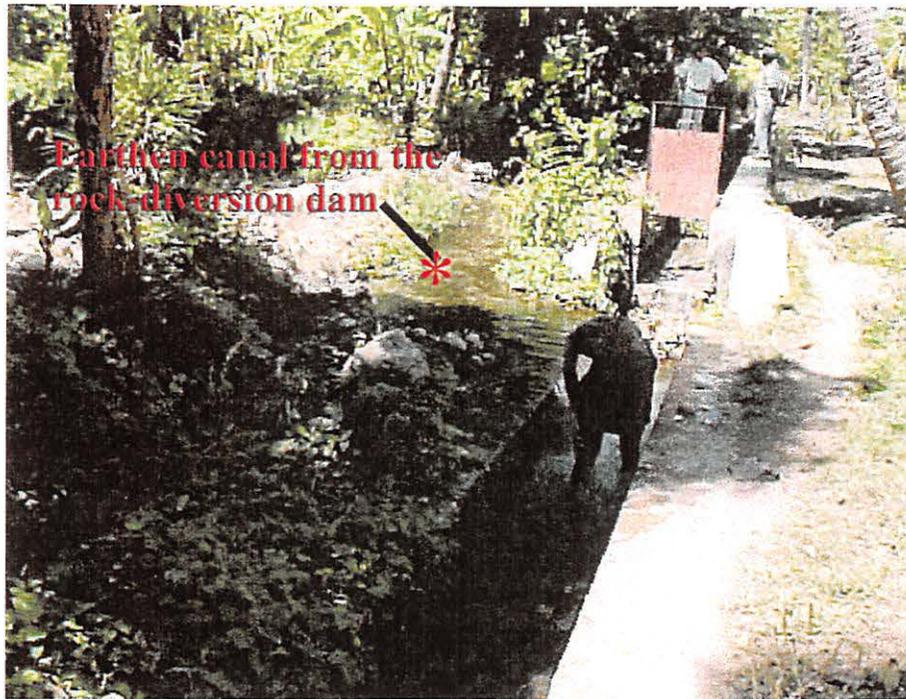
Photo 19. As no water is supplied from the system, irrigators have started to solve the problem by modifying the system's function. Such activities will eventually cause serious damage to the system.

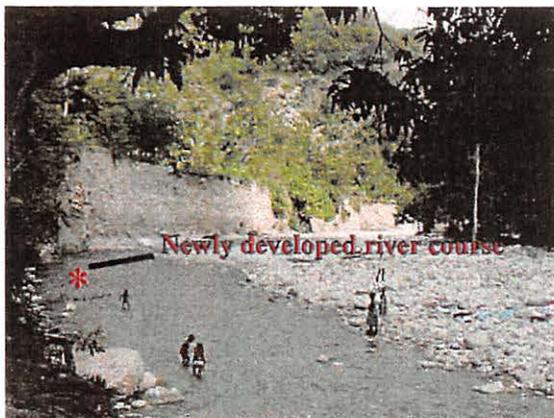
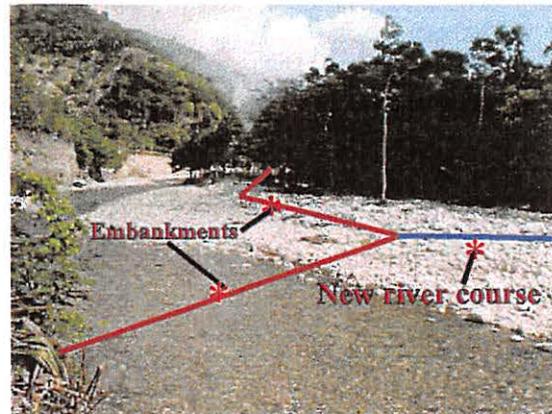
5. Diversion of the perennial river - The newly eroded east bank near the intake structure (photo 20) not only caused problems to the irrigation system but caused loss of community infrastructure. Without action to protect the bank, it will continue erode into further inland. One potential solution in addition to protecting the river bank with conservation structures is to divert the current course of the flow. **The area between the damaged intake and the present river course (photo 20b) needs to be excavated to open a new course away from the eroded bank. The excavated material may be used to block the current flow to guide the river into the new course. The eroded river bank should be re-graded with an acceptable slope and protect with rock-concrete structure or gabions.**

Photo 20. The flooding caused bank erosion and changes the river course further inland while depositing more sediments on the right side of the flow. Stabilization of the bank and change of the river course is necessary to protect the hillside. (b) shows approximate location of embankments and new river course open.

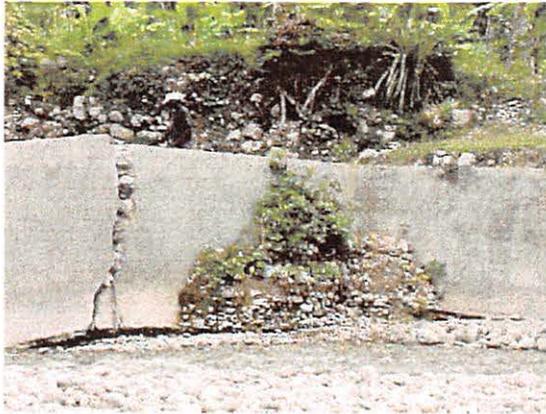
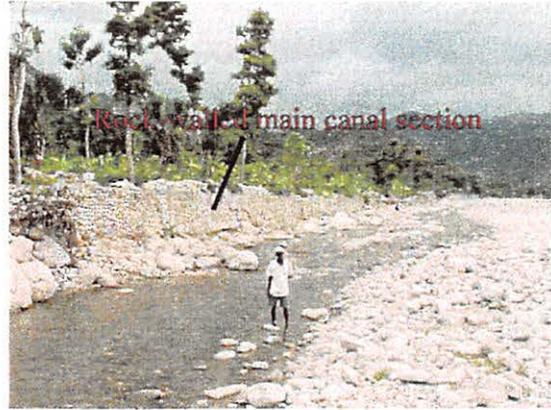
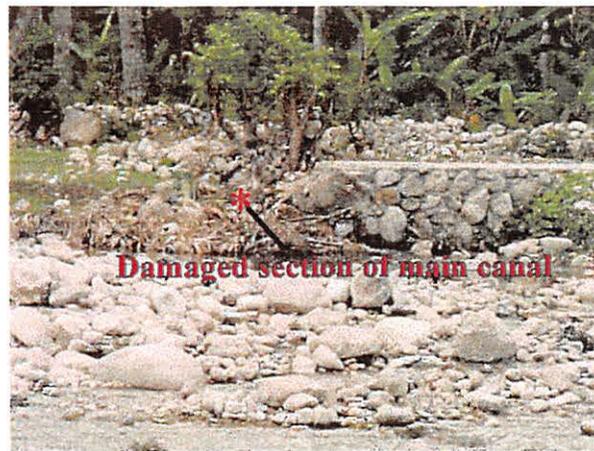
The intake structure of this site was washed off and broken in half and upper section of the main canal was destroyed (photo 21) as the river bank collapsed due to the flooding. One problem was that the main canal was installed along the fragile river bank. It would be necessary to re-route the main canal and relocate the intake structure. The local engineer has proposed to use an old structure located further inland from the broken section of the canal. As the elevation drop is adequate to convey water by gravity, it would be an acceptable proposal. Otherwise the intake structure should be located further upstream and the canal be rerouted in further inland. This may provide more land under irrigation while having the canal in a safer condition.

Photo 21. Damaged intake structure, upper section of the main canal and a broken section of the main canal due to bank erosion at the Belle Roche site.

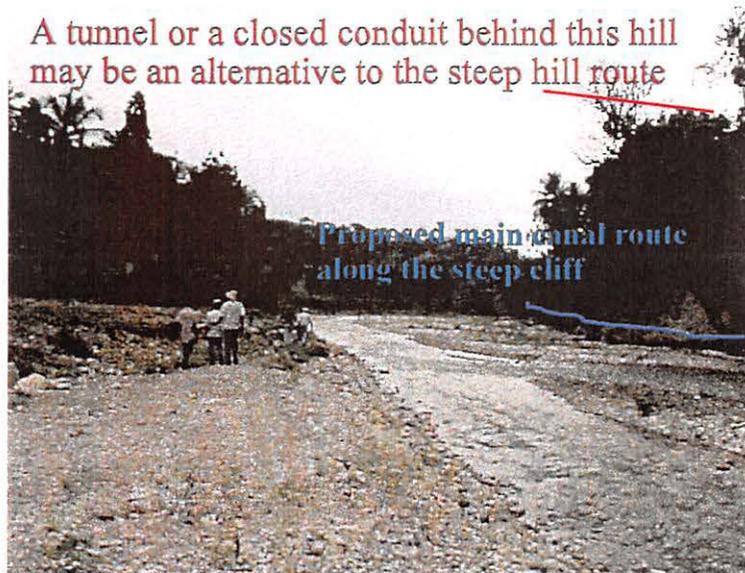
Photo 24. A steep cliff on the west bank will be a difficult task to route the main canal as proposed. An alternative would be to install a closed conduit or a tunnel behind the hill. This section of the proposed main canal is relatively short.

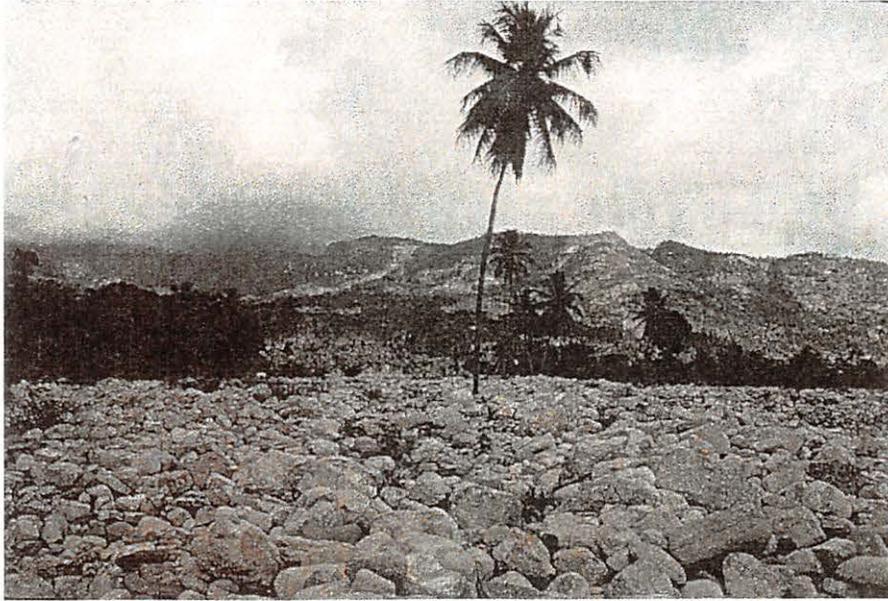
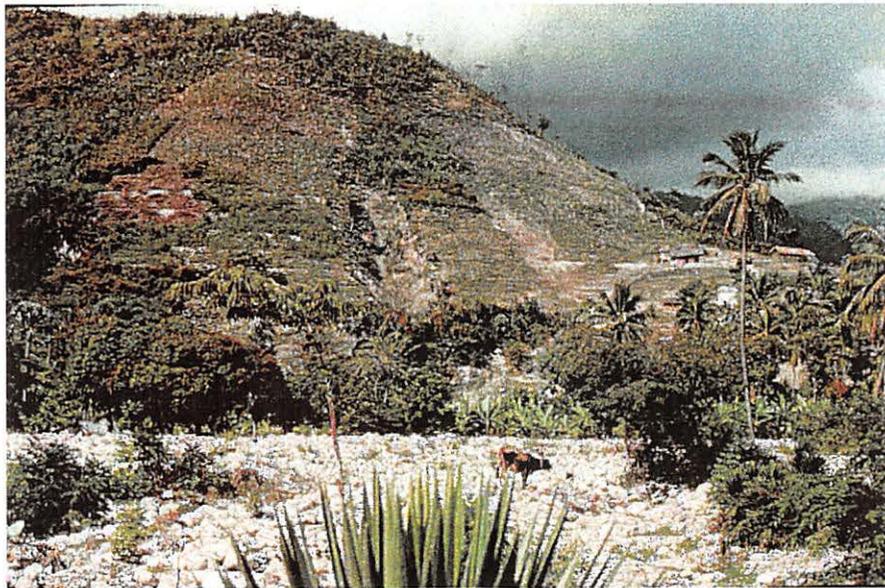
The foothills surrounding the Plantil river appeared fairly well vegetated (photos 27). The foothills surrounding the intermittent stream were less well vegetated (photo 26a) and some gully formation was evident nearby (photo 26b). Nevertheless, the extent of flooding damage that occurred in the neighborhood of the irrigation system cannot be explained by the runoff from these foothills. Clearly, much of the water flow in the two streams comes from higher up

Photo 26. Large, dry riverbed of intermittent stream that joins Plantil river below intake at Rodaille. a.) Note partially vegetated foothills in background, with evidence of cultivation on slopes; b.) gully formed on nearby cleared hillside.

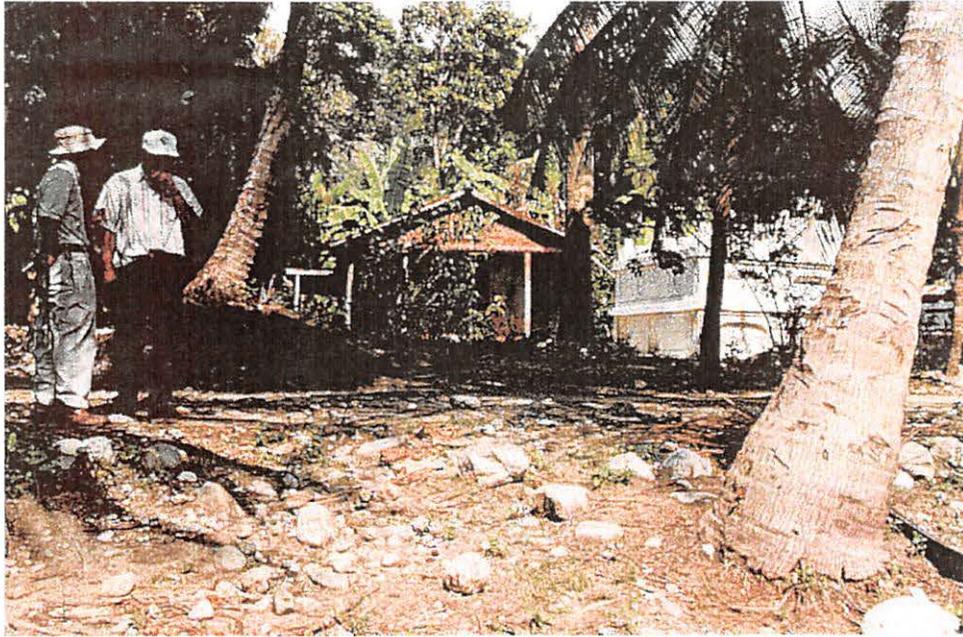
Photo 28. Dwelling and tomb across from damaged canal intake at Rodaille. Brown stains on the lower section of tomb show watermarks indicating level of floodwaters from Hurricane Georges a few meters above normal level of stream. Dr. Yoo and Marc-Eddy Martin shown at left of photo.

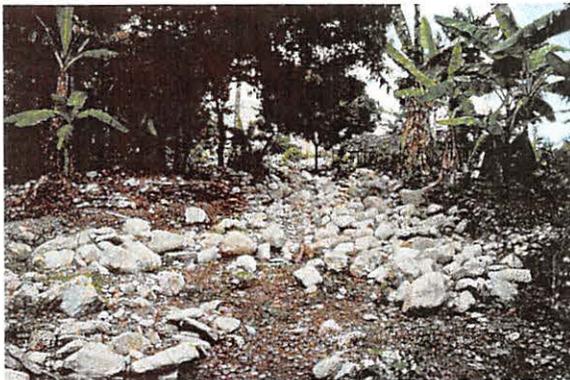
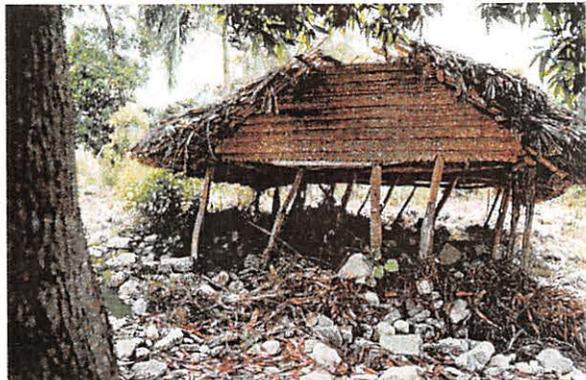
Photo 29. Boulders deposited by Hurricane Georges by overflow from intermittent stream shown in a.) farmland; b.) destroyed farm structure.

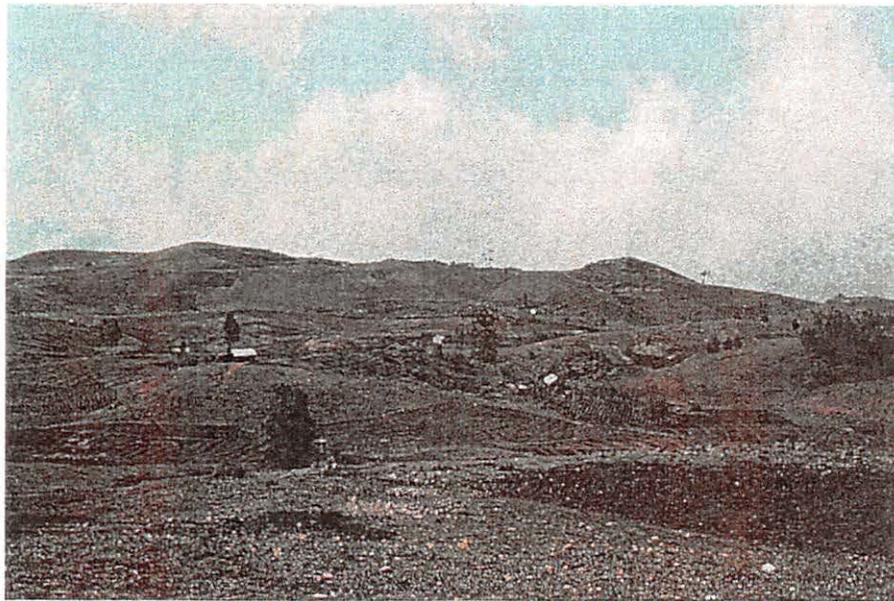
Photo 30. View of Seguin showing barren hillsides devoid of trees and with vegetation grazed to a few centimeters of the surface.

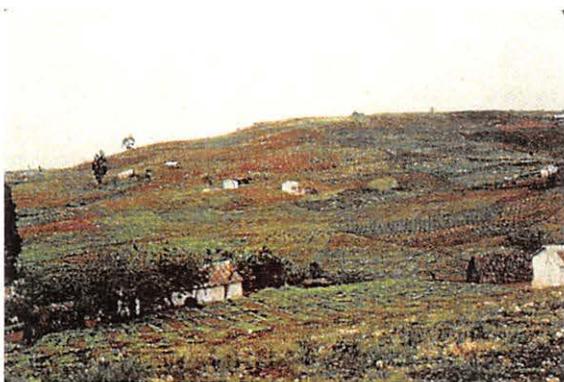
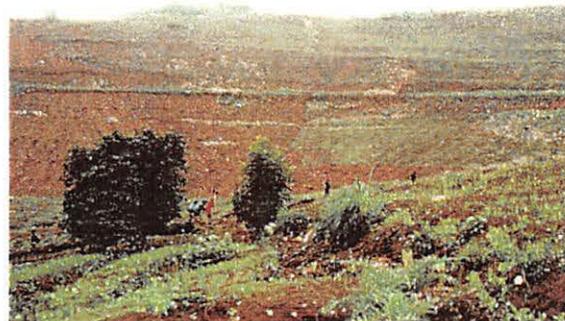
Photo 31. Farming at Platon L'Etang, near Seguin, without use of soil conservation practices. Few trees and little natural vegetation remains. b.) Steep hillside in background shows eroded surfaces and poor land husbandry.

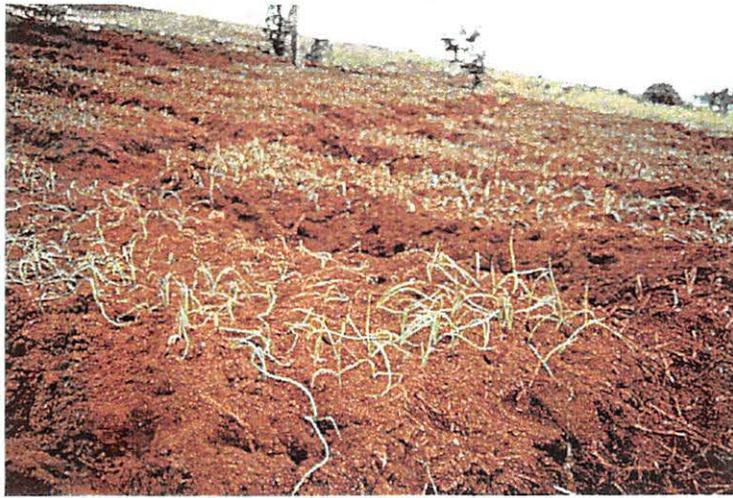
Photo 32. The vegetable production typical of this region does not provide adequate cover of the soil. Recently transplanted onions on raised beds shown here are typical of the agriculture in this area. Cabbage, carrot and Irish potato are other important crops.

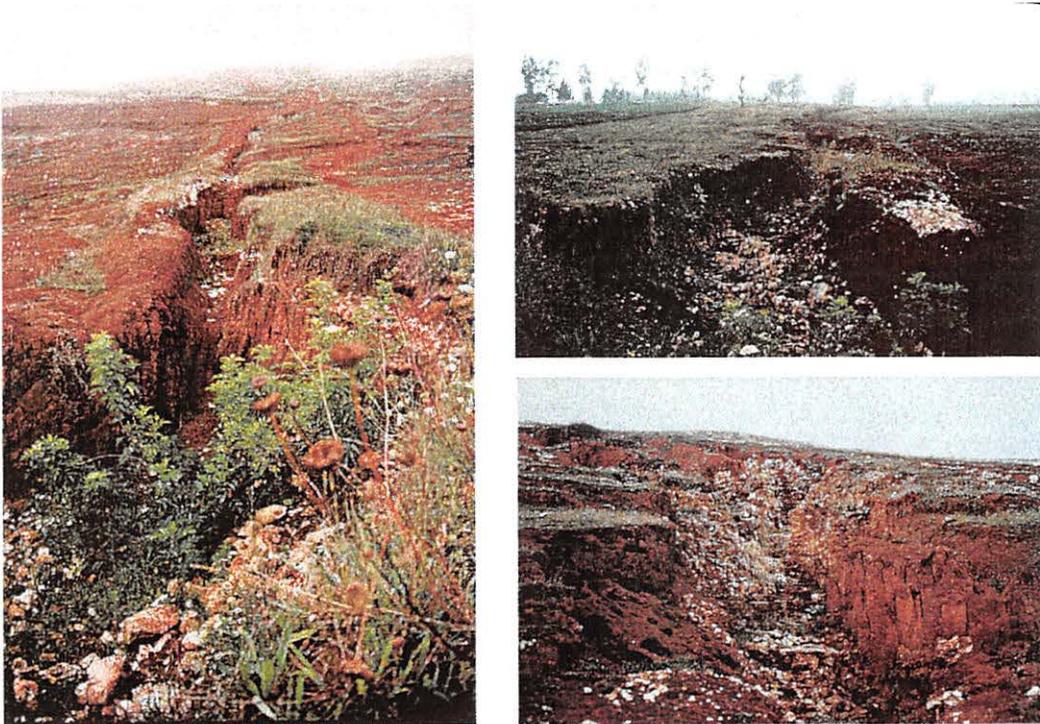
Photo 33. Gullies on moderate slopes near Cassédent. Note sparse vegetation. Unless corrective measures are taken, gullies like these will spread at an alarming rate.
