March 1999

**Technical Assessment of the Irrigation Systems of Marigot
and Jacmel and Preliminary Observations
on the Marigot Watershed**

Kyung H. Yoo and Dennis A. Shannon

**SECID/Auburn PLUS Report No. 47
USAID/Haiti Agriculture and Economic Growth Office**

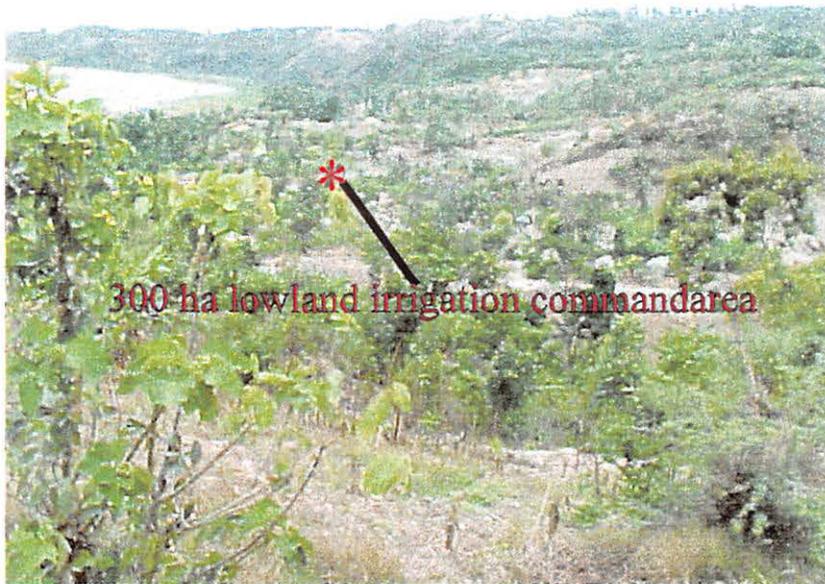
We were told that the system will require up to 17 km of main conveyance canal, primarily along the hills, to irrigate a low land across the river from Jacmel and the hillsides (photos 22

Photo 22. The 300 ha major irrigation command area, the lowland on the west bank of the Jacmel River.

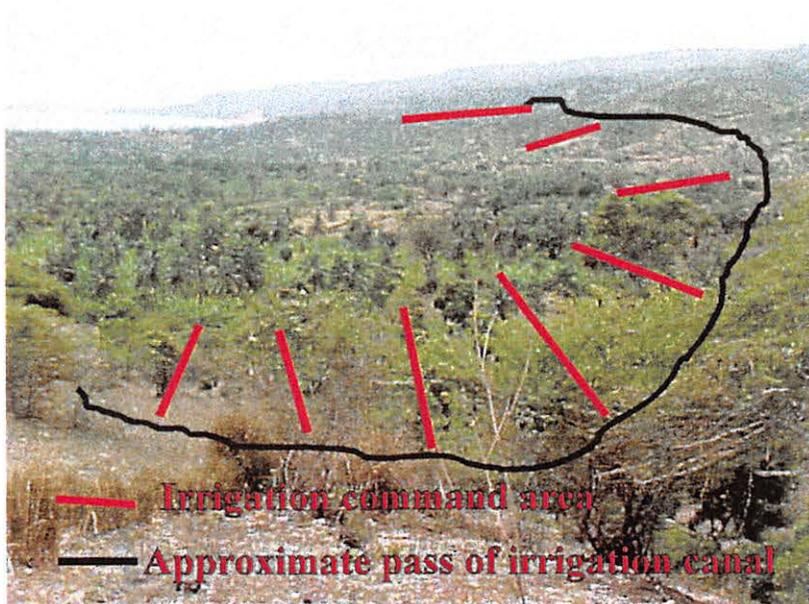
and 23) along the canal. The proposed total irrigation area is around 500 ha, around 300 ha of the low land and remainder on the hillsides along the canal. The most difficult part of building this system is to build an upper section of the canal immediately after the proposed intake site which will run along the steep river bank (photos 24). The site proposed to install an intake structure seems to be adequate as a natural rock on each side of the river may be used to anchor the structure (photo 25). **Since the system will be used to irrigate steep hillsides along the canal, it is extremely important to train the irrigators for soil and water conservation such as bench terraces. Without proper control of the irrigation water at the field level, more severe soil erosion problems will develop than without additional water to the field.**

Photo 23. Approximate pass of the proposed irrigation canal along the hillside.

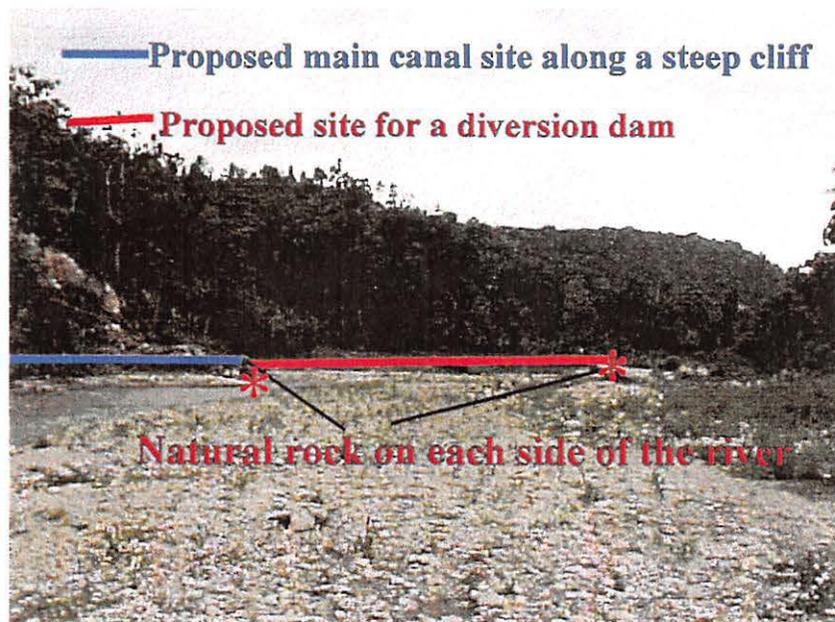
Photo 25 Proposed intake and upper section of the main canal route.

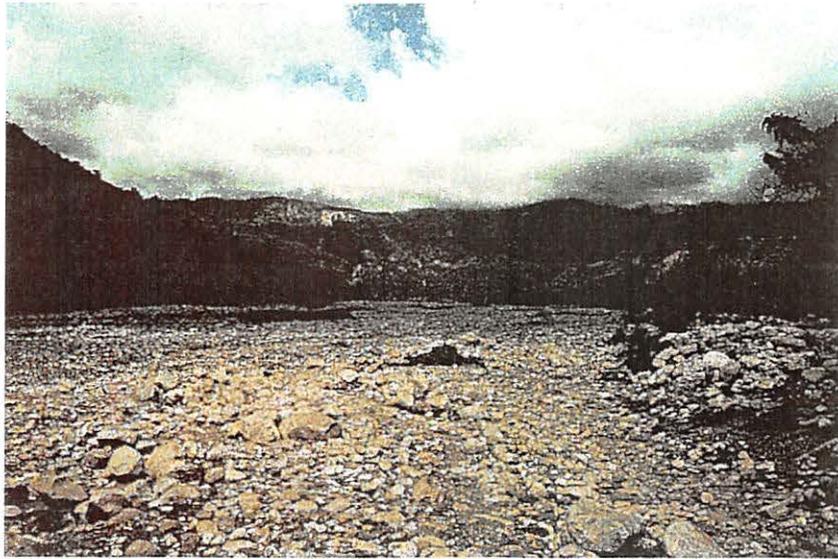
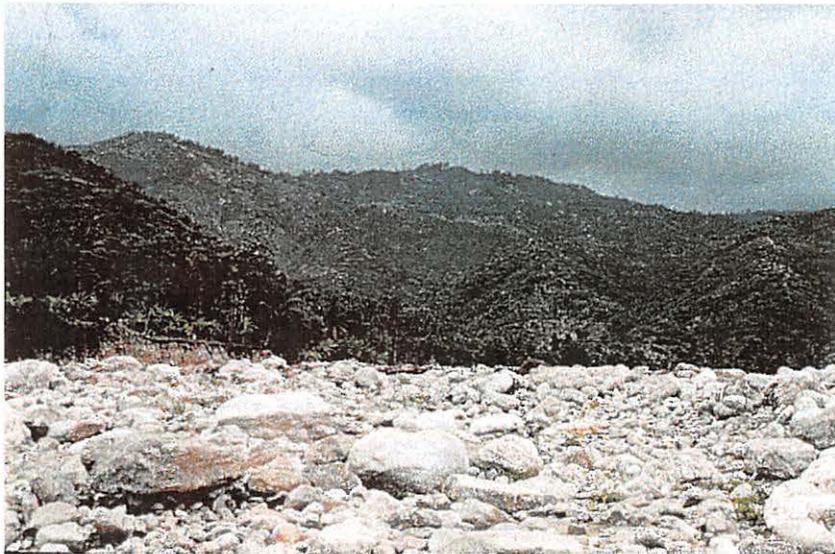
During periods of normal flow, the Plantil is an unimpressive, shallow stream, perhaps 5-6 m across at its widest point. During Hurricane Georges, it was able to fill a very sizeable streambed (photo 27), cut several meters into a high bank (photo 17) and overflowing its banks at the narrowest point (photo 11). The tomb shown in photo 28 has watermarks that indicate a water level perhaps 2-3 m above the stream banks and 4-5 m above stream level at the time of our visit. Equally impressive were the large rocks and boulders deposited by the overflow from the intermittent stream approximately 50 m from the banks of this dry streambed (photos 29). This indicates tremendous volume and force to move such large rocks such distances outside of the river bed. The fact that this deposition was on farmland that did not appear unusually stony suggests that the flow was unprecedented in recent times.

The foothills surrounding the Plantil river appeared fairly well vegetated (photos 27). The foothills surrounding the intermittent stream were less well vegetated (photo 26a) and some gully formation was evident nearby (photo 26b). Nevertheless, the extent of flooding damage that occurred in the neighborhood of the irrigation system cannot be explained by the runoff from these foothills. Clearly, much of the water flow in the two streams comes from higher up

Photo 27. Views of Plantil riverbed showing vegetated foothills in background.
